### CAPE DAM-BREACH & CHANNEL RESTORATION

REGIONAL ENGINEER	DATE	SAN MARCOS, TEXAS	
PROGRAM SUPERVISOR	DATE	SAN MARCOS, RIVER	
ASST. REGIONAL DIR.	DATE	HAYS	TEXAS
DIVISION	INITIALS / DATE	CAPE DAM-BREACH & CHANNEL RESTORATION	
		VICINITY MAP, SITE PLAN AND DRAWING INDEX	
DESIGNED	W. STANCILL	DRAWN	W. STANCILL
CHECKED	W. RICE		
DATE	APRIL 2016	PROJECT NO.	6R-TX-2016-002
		SHEET 1 OF 7

This report was designed & drawn by W Stancill and checked by W Rice in a date that appears to be April 2016. We know from the TCEQ Information Sheet filed May 3, 2016 (see left) that Wayne Stancill is an 1) employee of/contractor to USFWS; and 2) lives in South Dakota. Why is a Pierre, South Dakota-based USFWS engineer being used on a Central Texas river? Does USFWS not employ a single engineer within Texas?

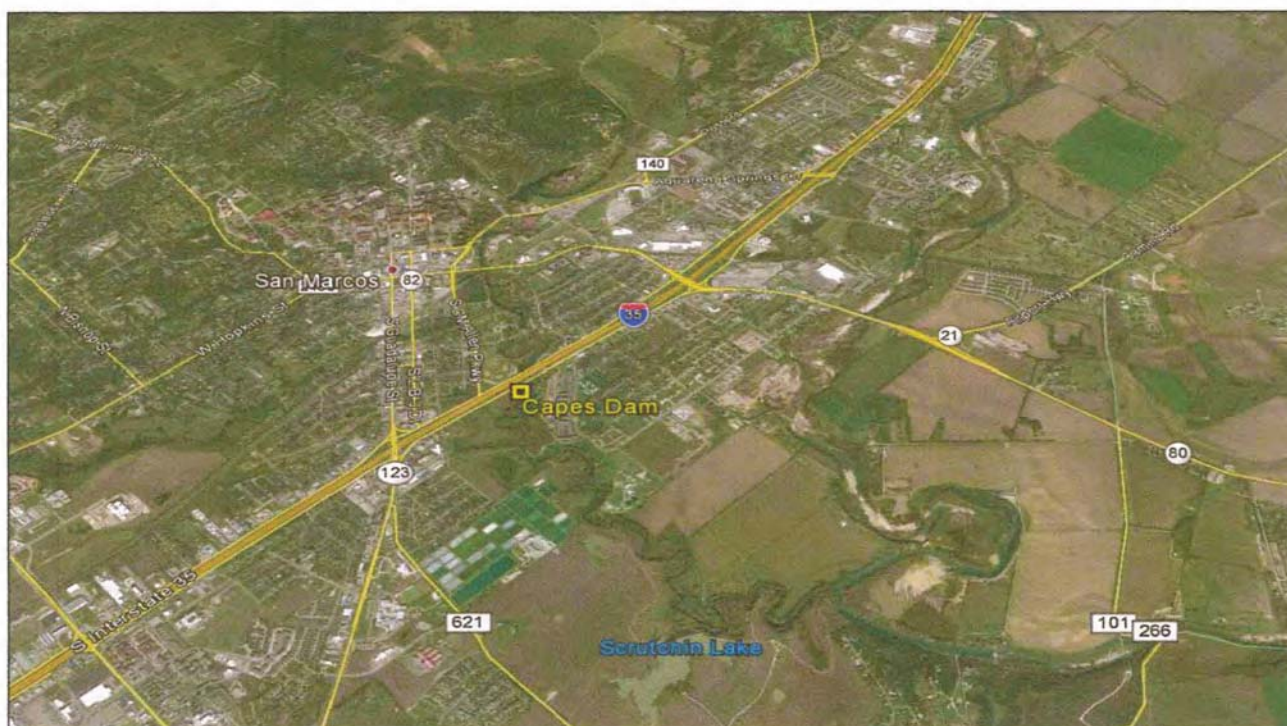
**Figure 1a. Project Area Map (above) as depicted in US Fish & Wildlife Service (USFWS) report dated April 2016.**

This project aerial photograph is deficient because 1) Mis-identifies the location of Capes Dam, the subject of the report, as being directly next to I-35; 2) is taken at such a high elevation that it doesn't show any detail; and 3) is mis-appropriately named “Capes Dam-Breach & Channel Restoration.” This report is about *removing* Capes Dam, not channel restoration. The channel will be highly-disturbed, and not restored, for many years after, if Capes Dam is removed.

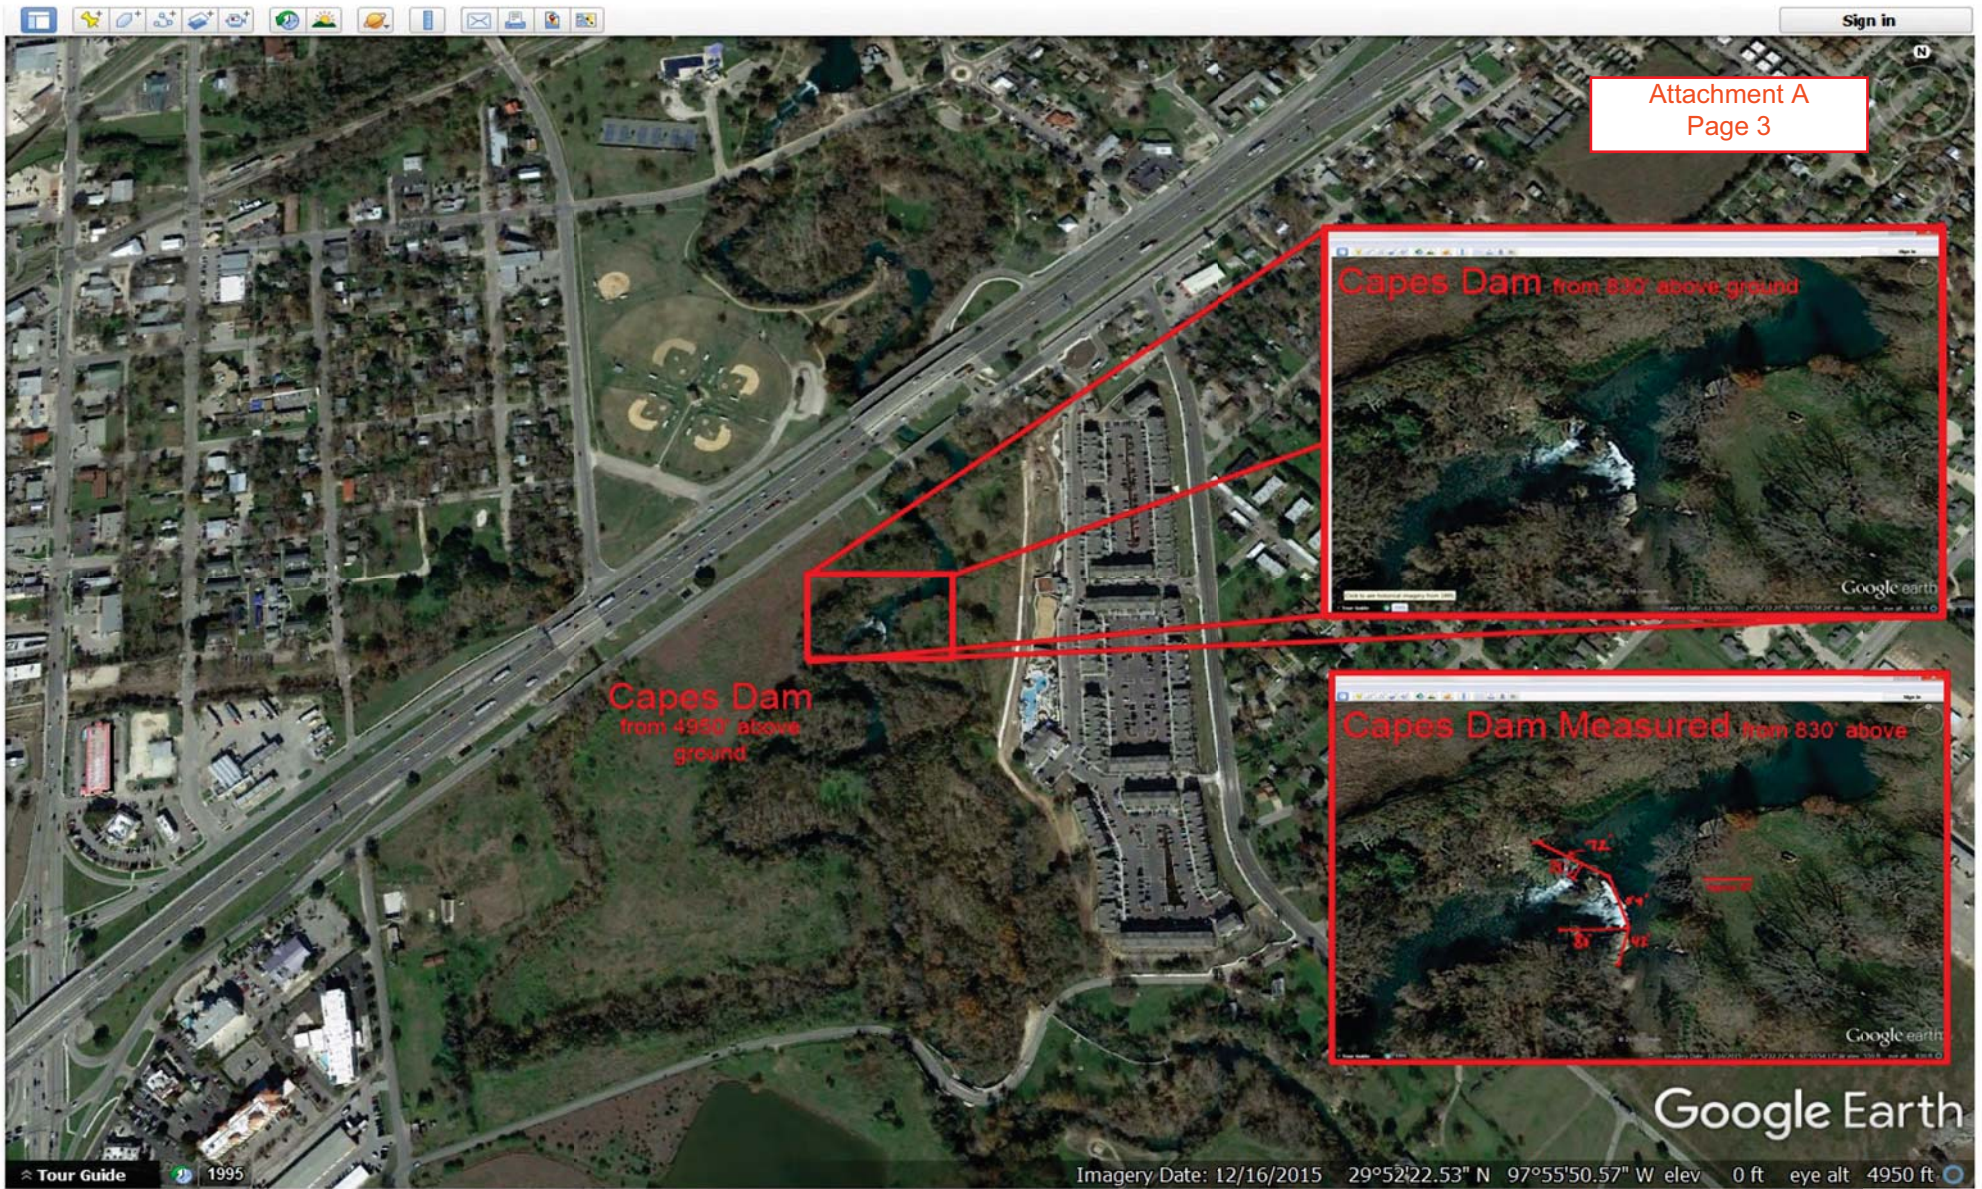
*Figure 1b. Project Area Map (above) as depicted from Google Earth image, 12/16/2015.*

This project aerial photograph remedies the deficiencies shown in Fig 1a -- 1) Capes Dam, the subject of the report, is correctly located; 2) Base photo image is taken at 4950' above ground, as well as offering two inset photos taken at 830' above ground. The photo inset (lower right) provides measurements for the three main lateral parts of Capes Dam, measuring from North to South: 72 ft in linear length, 54 ft, and 42 ft, **for Capes Dam having a total documented measured length of 168 feet.**

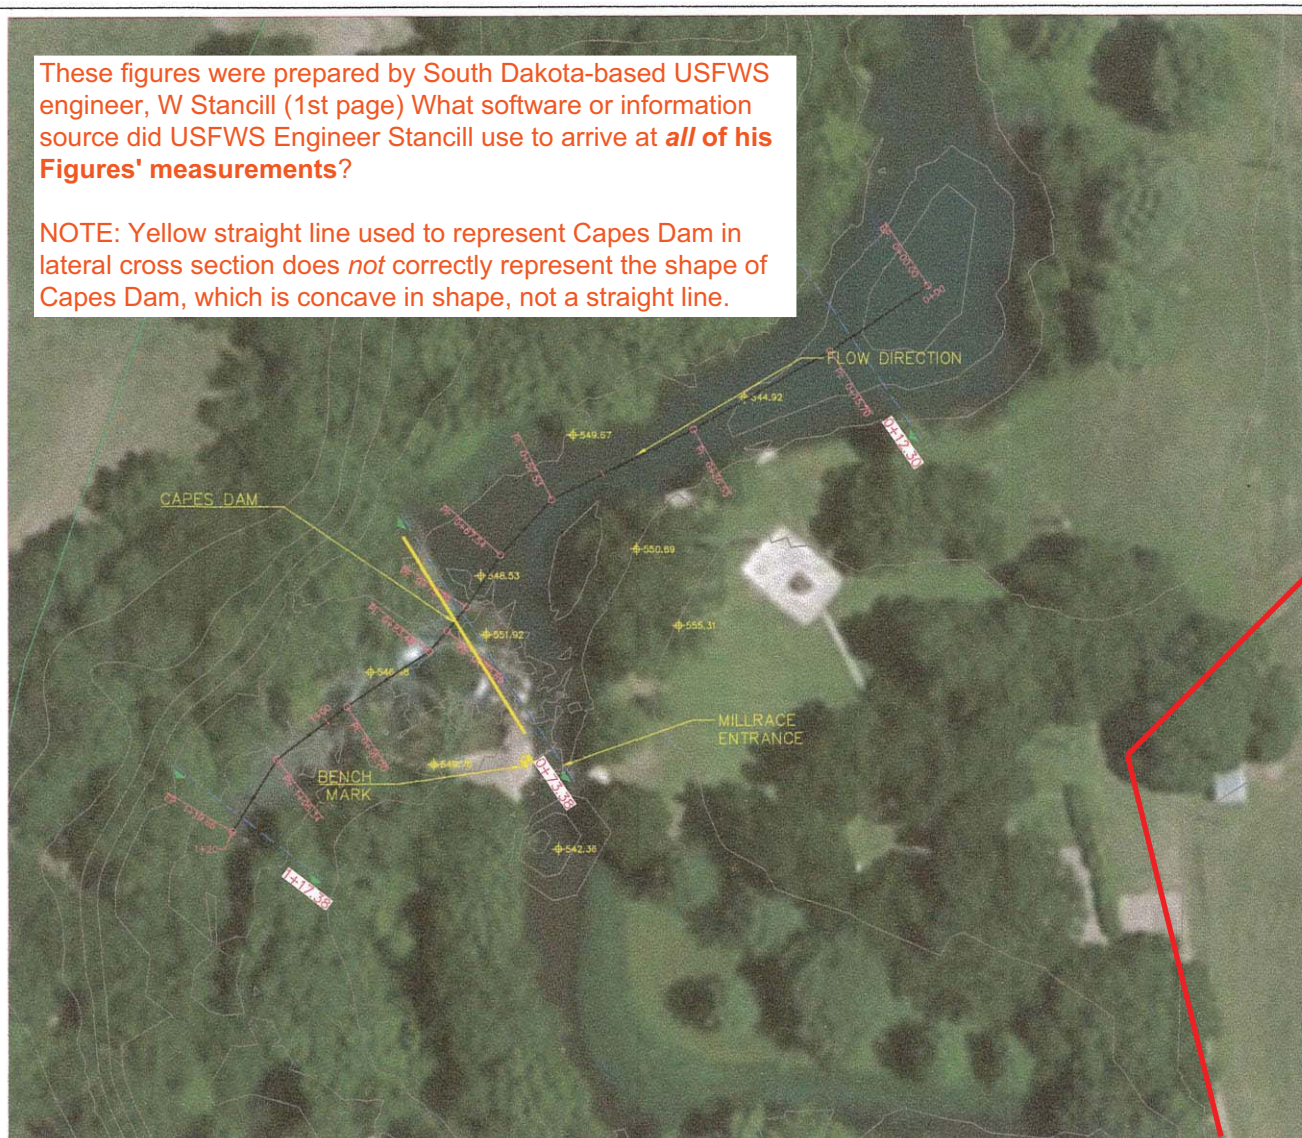
EXISTING SITE  
NO SCALE

Use of outdated photograph; This area now occupied by 24-acre apartment complex with an estimated 80-90% impervious cover, all of which drains its rainwater run-off directly into the San Marcos River (2 drains) or the Mill Race (3 drains.)

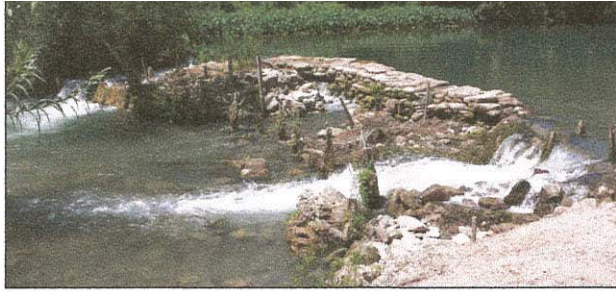
CAPE DAM, ~ 300 CFS, VIEW ACROSS DAM FROM MILLRACE INLET  
See pages 7-9 of this report for documented photos of 266 CFS, 630 CFS, and 400 CFS.

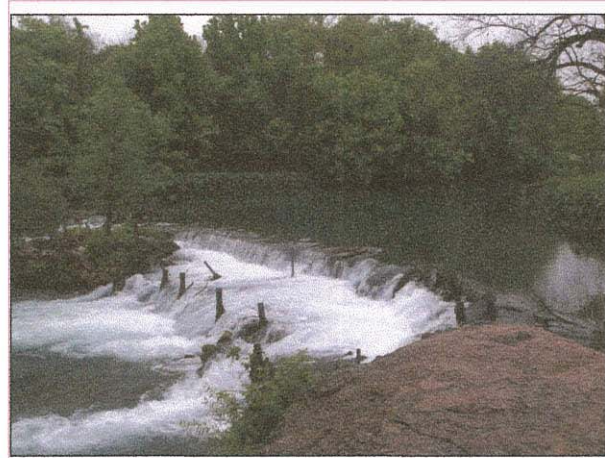
CAPE DAM, ~ 600 CFS, VIEW ACROSS DAM FROM MILLRACE INLET  
These photos are dated April 2016 (see legend below); there was no recorded 600 cfs flow in April 2016.

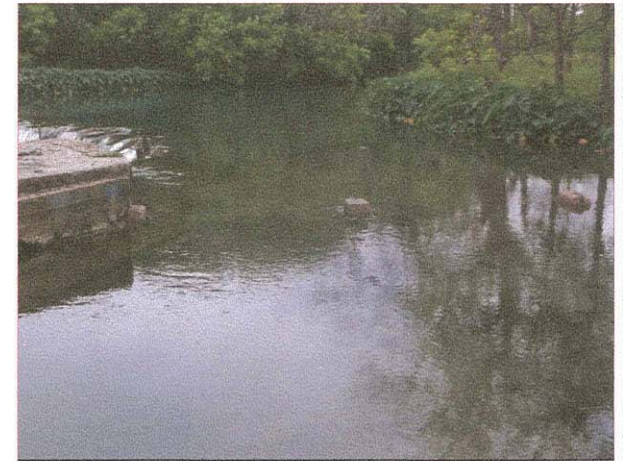
MILLRACE INLET, VIEW DOWNSTREAM TO UPSTREAM  
The pediments of what once was the Mill Race headgate only begin to be visible when water discharge falls below approx. 280 cfs.

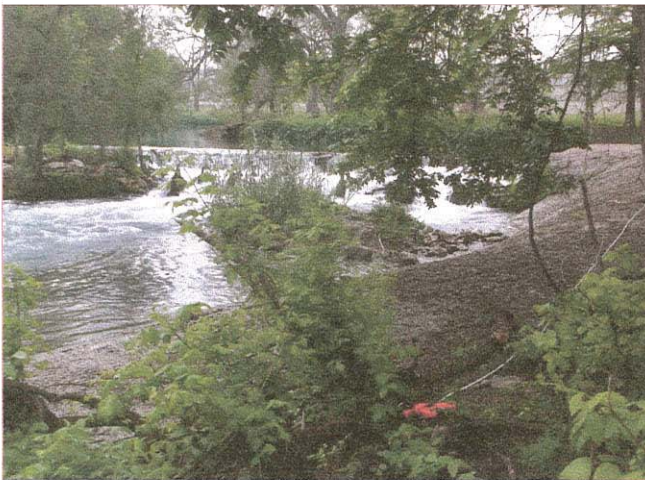
CAPE DAM, ~ 600 CFS, VIEW DOWNSTREAM TO UPSTREAM

If this were 600 cfs, the water would be much higher, covering the concrete apron on the north side of Thompson's Island. See pages 7-9 of this report for documented photos of 266 CFS, 630 CFS, and 400 CFS.

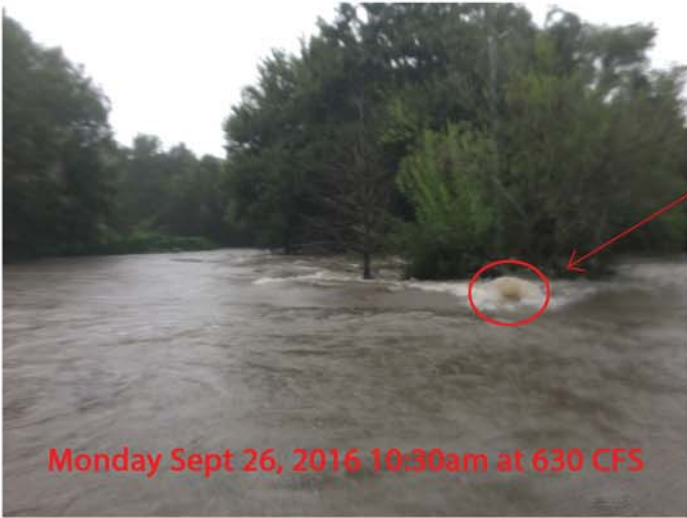
Monday Sept 26, 2016 10:30am at 630 CFS

Concrete pad covering parts of Capes Dam is completely submerged at 630 CFS

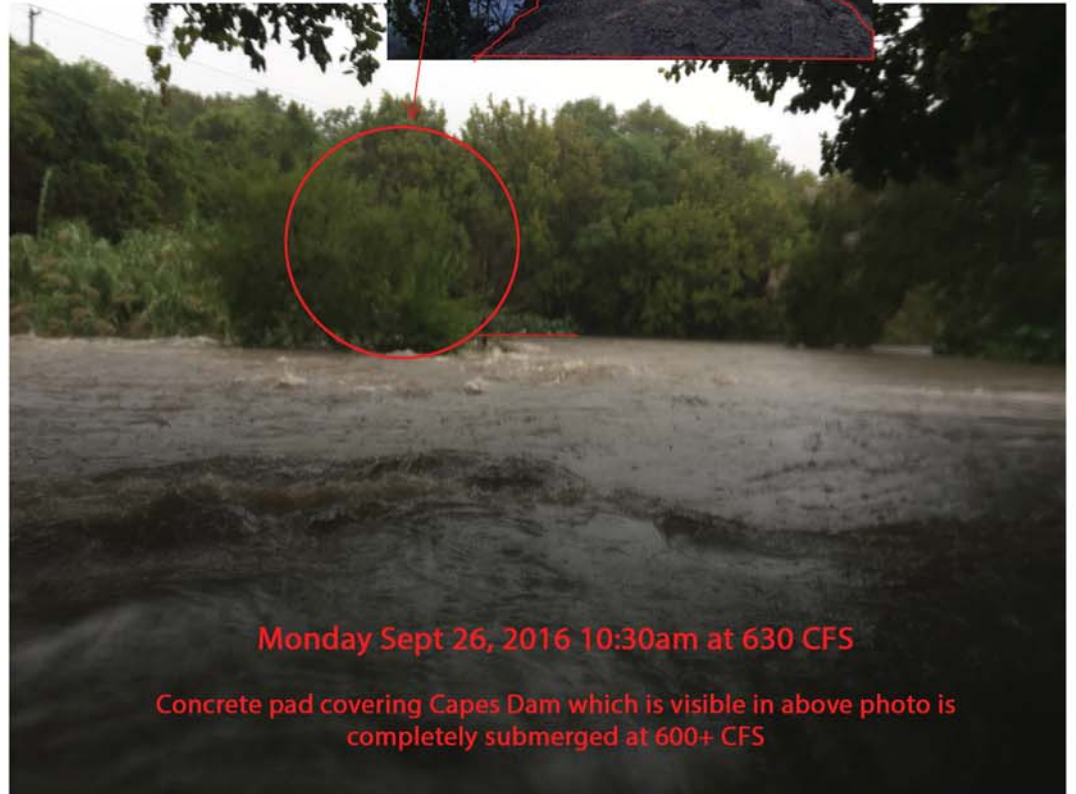
Monday Sept 26, 2016 10:30am at 630 CFS

Concrete pad covering Capes Dam which is visible in above photo is completely submerged at 600+ CFS

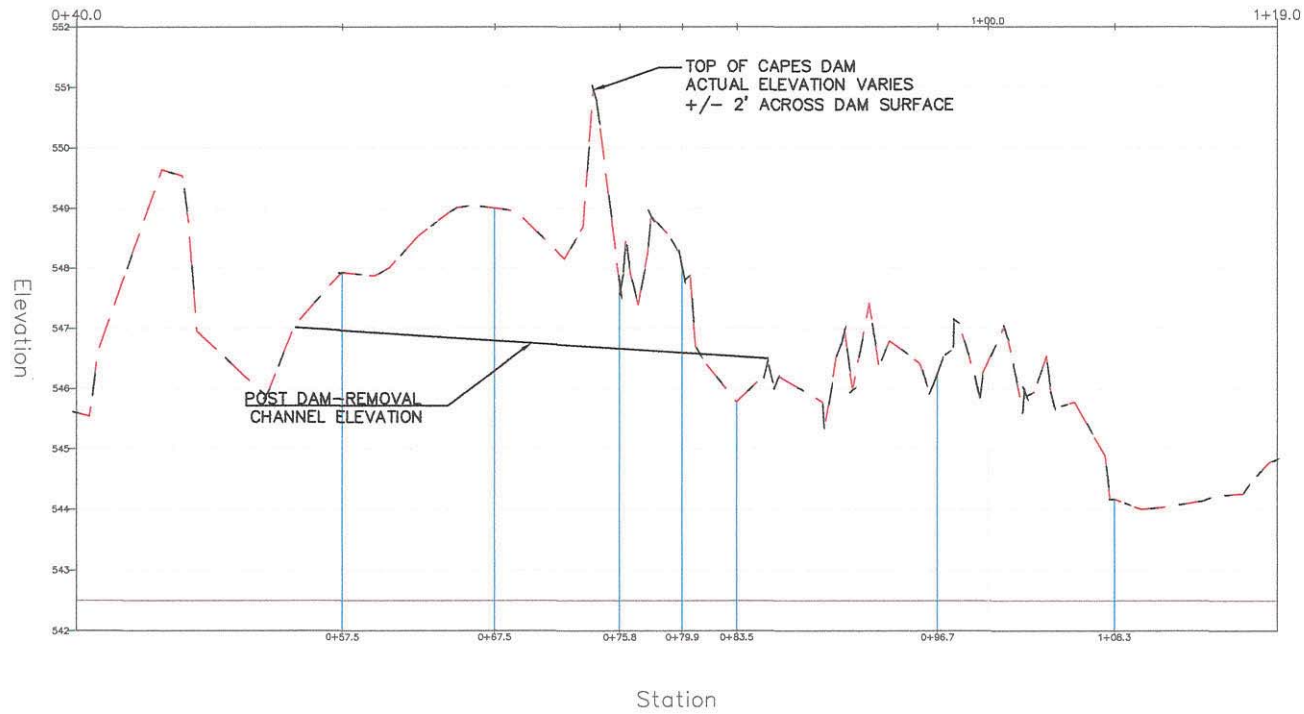
Because this Engineer's Drawing lacks a **Horizontal Scale**, no measurements can be made of the amount of sediment that will either 1) be removed and should be included in both TCEQ Info Sheet for Dam Removal and TPWD Sand and Gravel permits; **OR** 2) be removed by the river over time, and be sent downstream, greatly increasing sedimentation rates downstream from what once was Capes Dam.

**This 3D volume of sediment taken away "Post Dam-Removal" must be able to be measured, quantified, and correctly described before any action to remove Capes Dam can occur.**

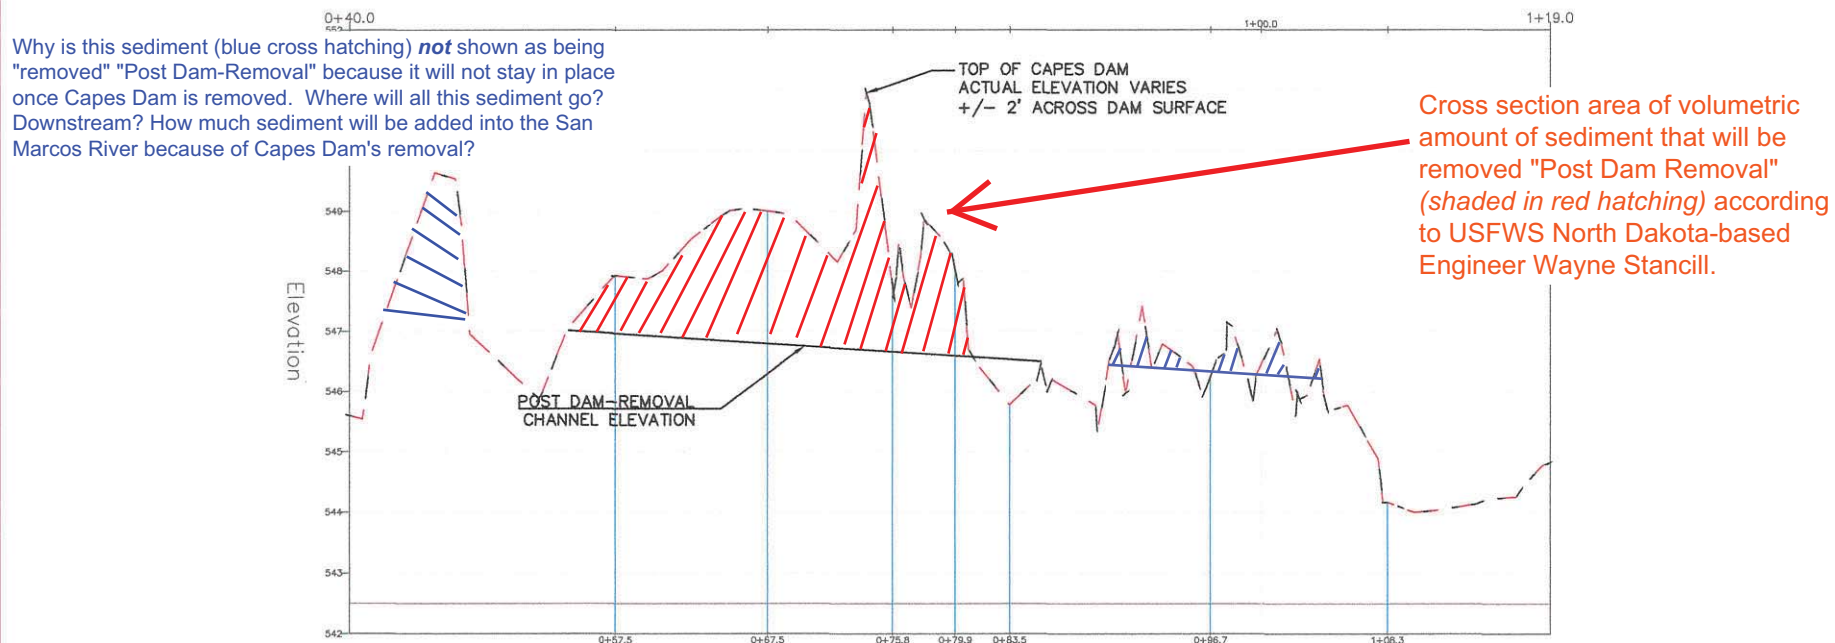
1) Will the "Post Dam-removal Channel Elevation" created by removal of the sediment that currently exists in the area shaded in red hatching **be accomplished by man-made removal?**

2) Will the "Post Dam-removal Channel Elevation" created by removal of the sediment that currently exists in the area shaded in red hatching **be accomplished by the river, over time?**

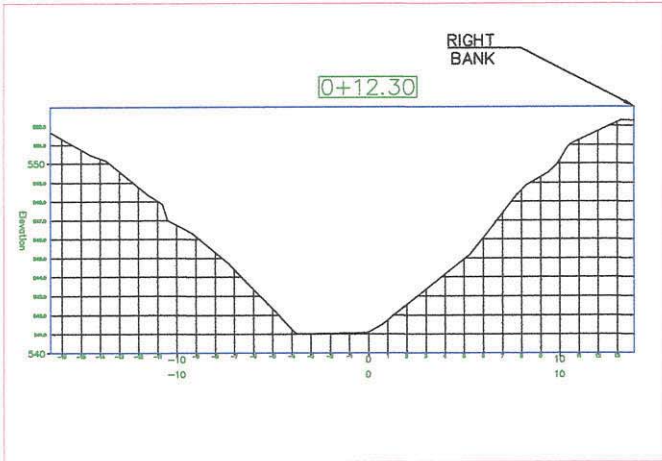
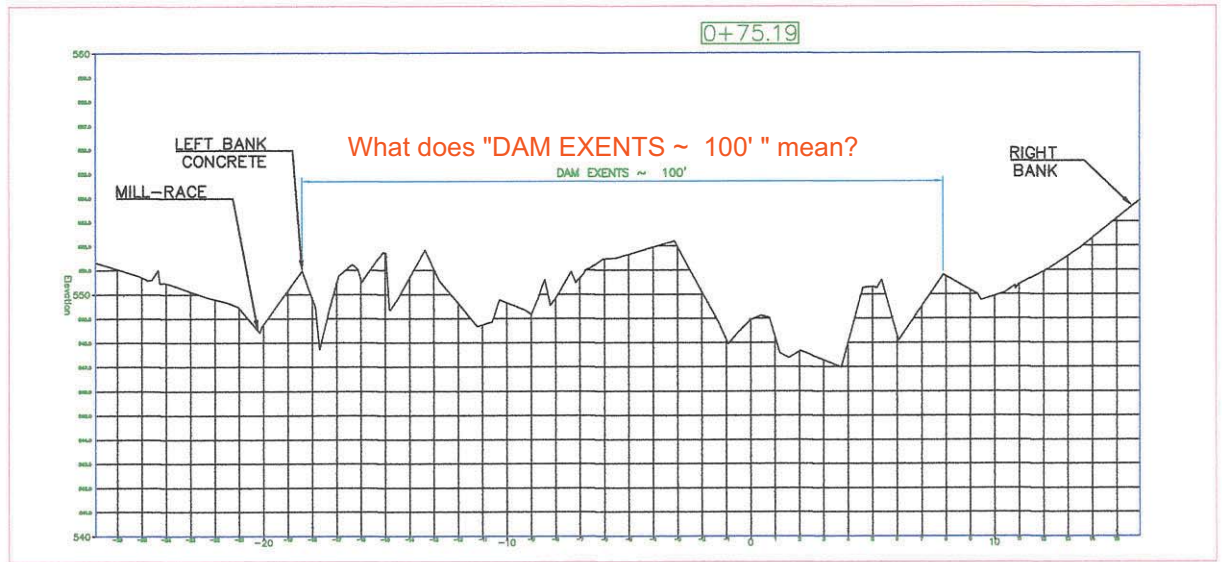
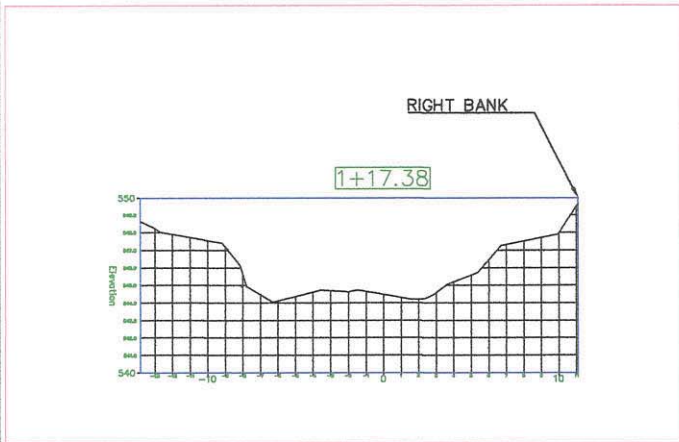
None of these drawings have a horizontal scale so measurements of the areas (2D) and volumes (3D) are not possible. Is this typical of the quality of work done by engineers employed or contracted to USFWS? The entire point of engineers' drawings are to have a certified measurements of physical structures. But when an organization assigns work to an engineer located over 1,000 miles away from the subject of his drawings, accuracy and useful data can be lacking.

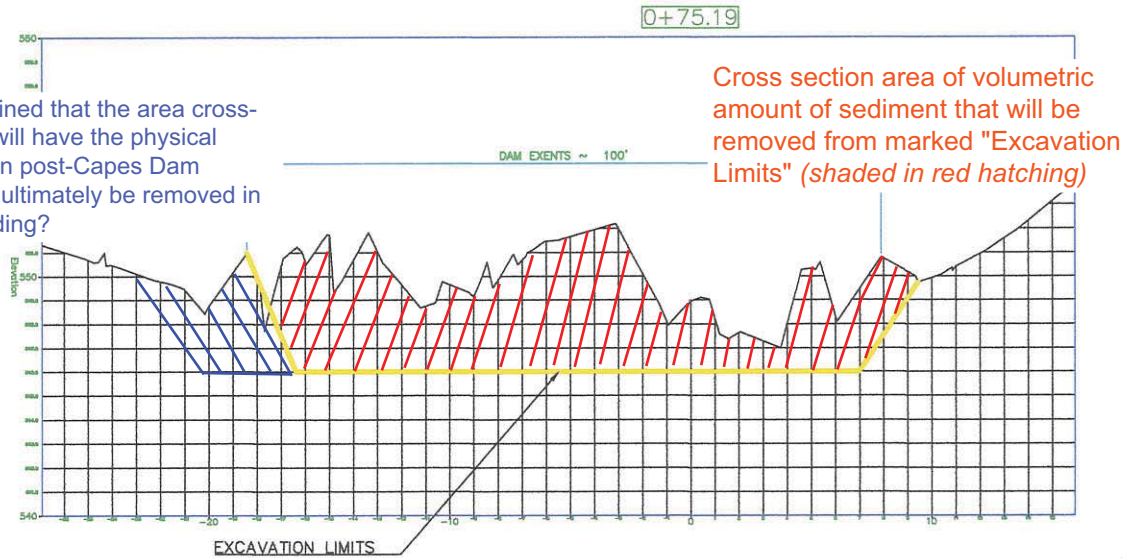
Cross section area of volumetric amount of sediment that will be removed from marked "Excavation Limits" (shaded in red hatching)

Has any geological work been done to investigate what rock Capes Dam is built upon? It appears that Capes Dam utilizes the upthrown side of a horst fault-block, part of the much larger Balcones Fault Zone. What will happen if this proposed Excavation of Capes Dam encounters an upthrown fault block that Capes Dam has merely utilized and enhanced?

Who has determined that the area cross-hatched in blue will have the physical integrity to remain post-Capes Dam removal and not ultimately be removed in subsequent flooding?

**Question:** What is being planned for the rainwater run-off drainage sewer pipes that drain the adjacent 24-acre apartment complex (which was omitted from these plans) of all rain-water? Three of these 5 drains empty into the Millrace. What will happen after the Millrace no longer receives fresh flows of water, and instead becomes a stagnant, Zika-mosquito-filled swamp? When it rains, and the 3 rainwater runoff sewage pipes dump their polluted water directly into the area formerly occupied by the Millrace, have any flood-studies been completed to show the effect on the now-dammed Millrace?

"4. **Excavated material deposited into the Millrace will be no larger than 8 cubic ft**" **Question:** Will individual boulders be no larger than 8 cubic ft (which can be approximated by a 2 foot-square cube)? What if individual boulders are larger than 8 cubic feet? Where will these larger boulders be deposited?

"5. **Rebar will not be removed from excavated material deposited in the Mill race.**" **Question:** Will concrete be removed from excavated material? Or will all materials, whether natural or man-made iron & concrete, be desposited into the natural-bank Millrace?

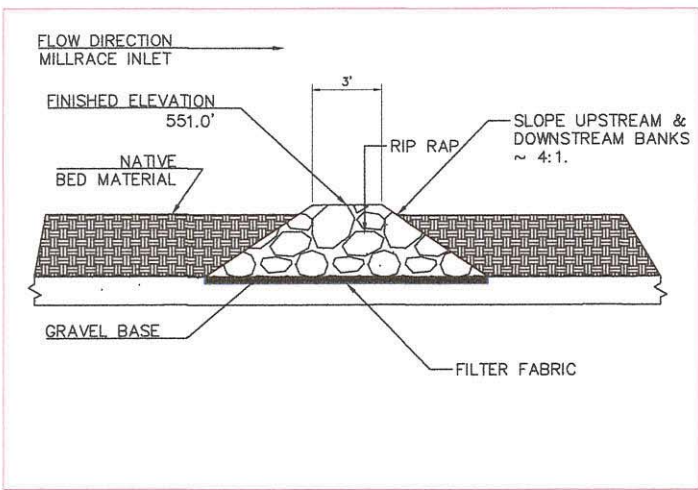
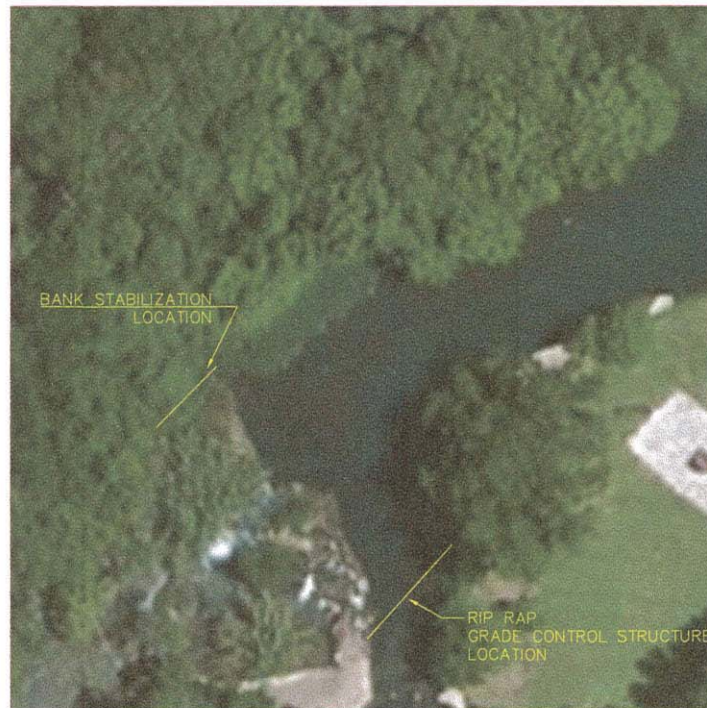
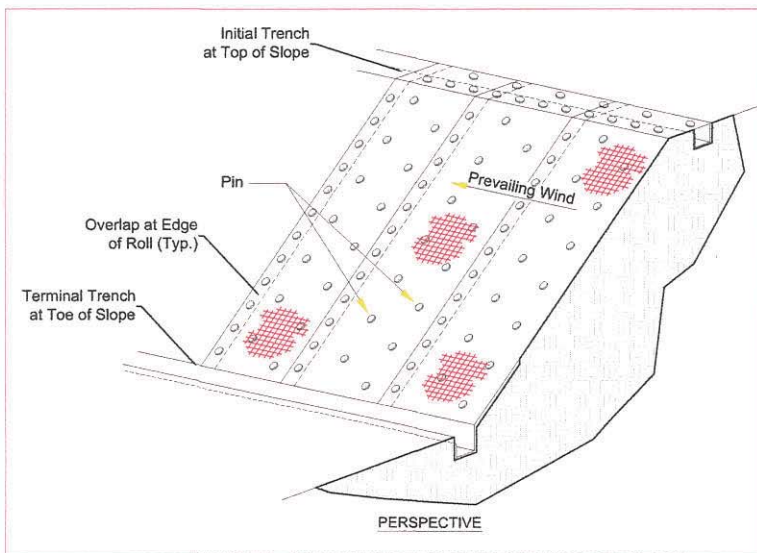
**WHY** does the Millrace HAVE to be damned-up and filled in?

**WHY** can't the San Marcos River and Millrace employ the **SAME Split-Flow regime** that Dr Thom Hardy (upon whose research Mike Montagne of USFWS has based his recommendations upon) is implementing in the hydrologic equivalent Comal River? (See [http://eahcp.org/index.php/habitat\\_protection/comal\\_springs/flow\\_split\\_management](http://eahcp.org/index.php/habitat_protection/comal_springs/flow_split_management) for discussion of Hardy-recommended Split-Flow of Comal River to create slow-moving Fountain Darter habitat.)

In the Comal River, Dr Hardy is recommending **the exact opposite of what is proposed for the San Marcos River**. In the Comal River a **Split-Flow regime is being created** between the Comal and the Old Channel **to provide better habitat in a larger area for the endangered Fountain Darter which prefer the slower-moving waters of the Old Channel**.

**WHY** can't our existing **Split-Flow regime** between the San Marcos River and the Millrace be maintained?
