### CAPE DAM-BREACH & CHANNEL RESTORATION

REGIONAL ENGINEER	DATE	SAN MARCOS, TEXAS	
PROGRAM SUPERVISOR	DATE	SAN MARCOS, RIVER	
ASST. REGIONAL DIR.	DATE	HAYS	TEXAS
DIVISION	INITIALS / DATE	CAPE DAM-BREACH & CHANNEL RESTORATION	
		VICINITY MAP, SITE PLAN AND DRAWING INDEX	
DESIGNED	W. STANCILL	DRAWN	W. STANCILL
CHECKED	W. RICE		
DATE	APRIL 2016	PROJECT NO.	6R-TX-2016-002
		SHEET 1 OF 7

This report was designed & drawn by W Stancill and checked by W Rice in a date that appears to be April 2016. We know from the TCEQ Information Sheet filed May 3, 2016 (see left) that Wayne Stancill is an 1) employee of/contractor to USFWS; and 2) lives in South Dakota. Why is a Pierre, South Dakota-based USFWS engineer being used on a Central Texas river? Does USFWS not employ a single engineer within Texas?

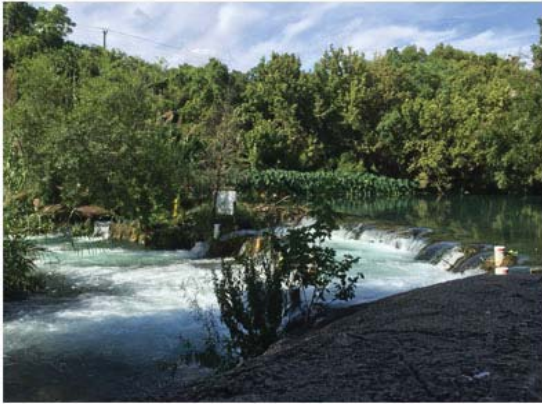
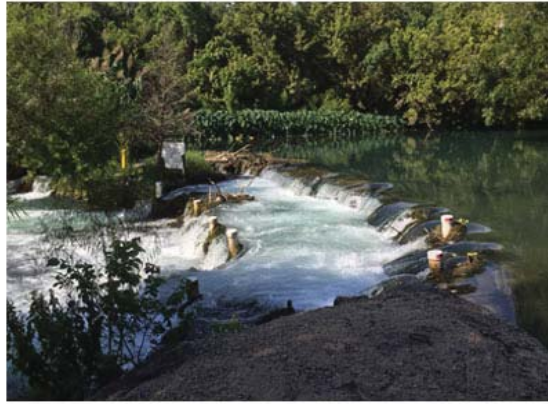
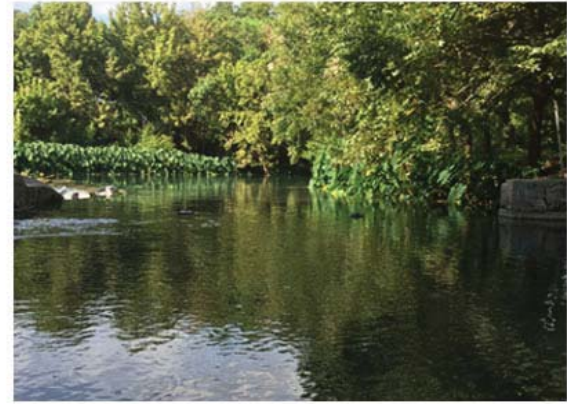
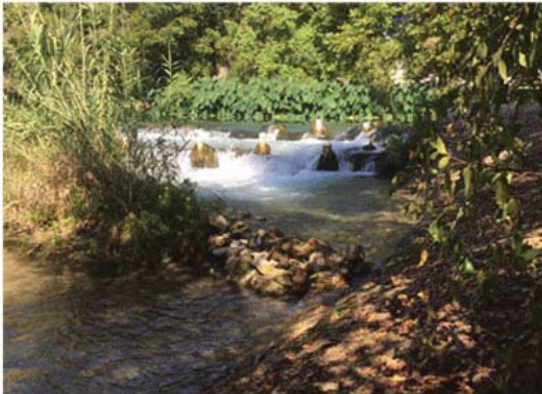
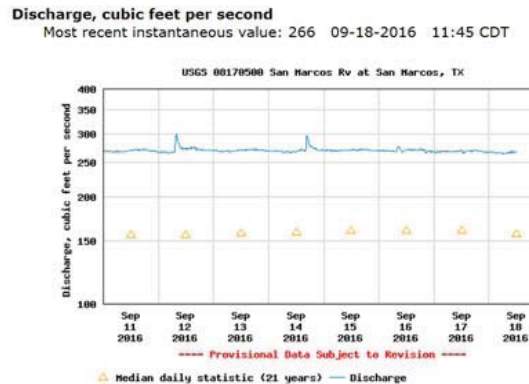
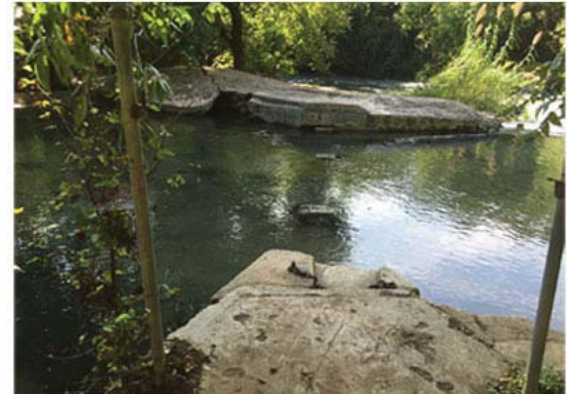
All photos taken when USGS measured discharge was 266 cfs

Contrast these photos with known measured CFS to undated photos in USFWS April 2016 report on the removal of Capes Dam entitled "Capes Dam-Breach & Channel Restoration" The vastly *over-estimated flow-rates* on the undated photos of the **USFWS are incorrectly displayed on the order of 100-300 cfs.**

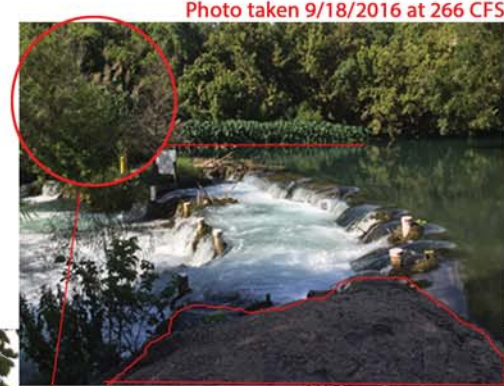
Photo taken 9/18/2016 at 266 CFS

Concrete pad covering parts of Capes Dam is completely submerged at 630 CFS

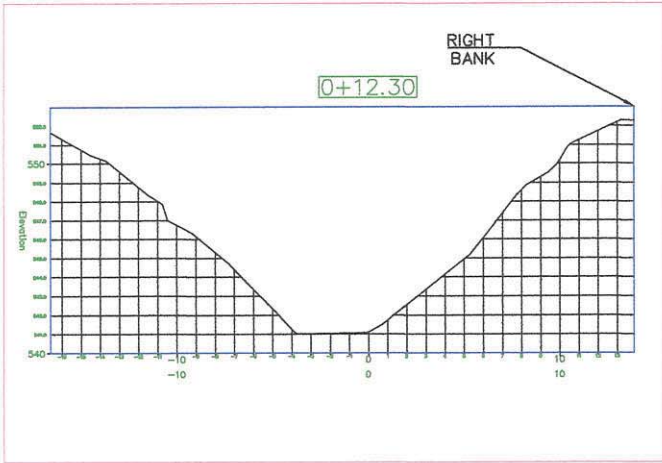
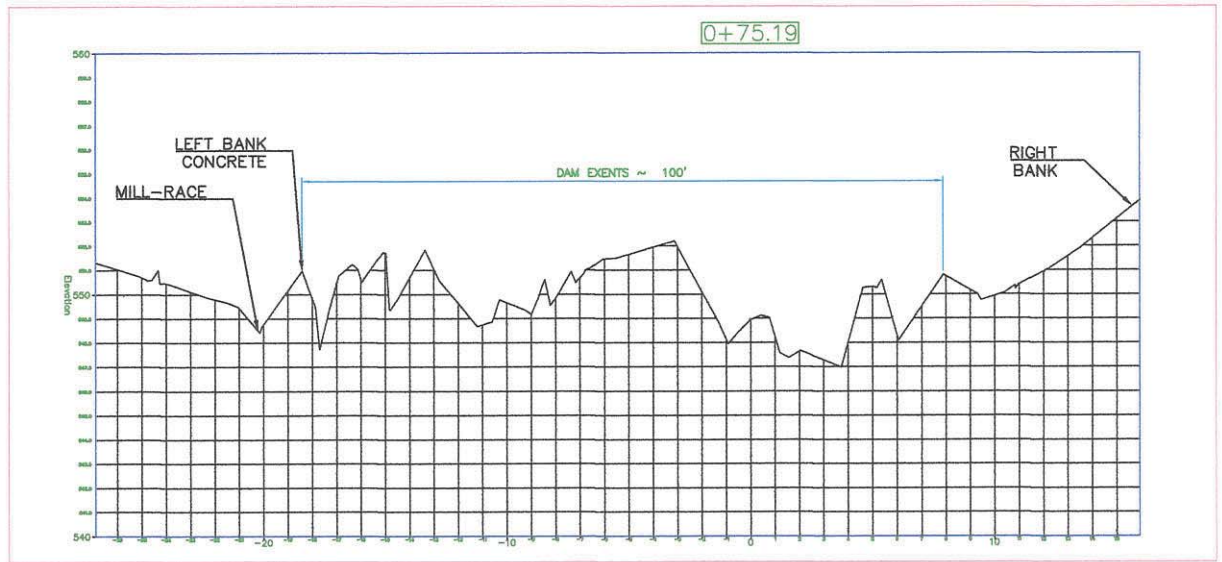
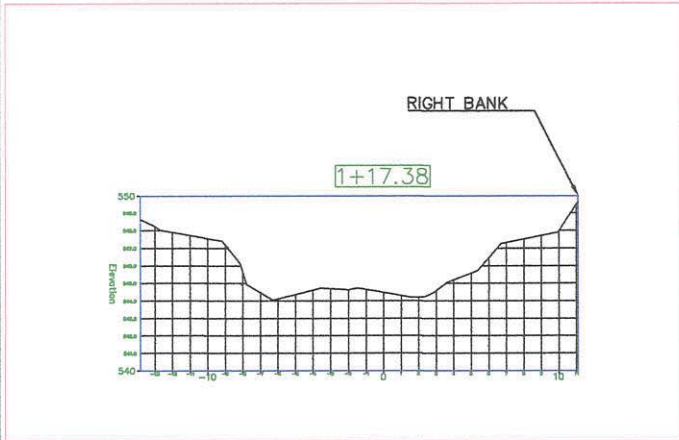
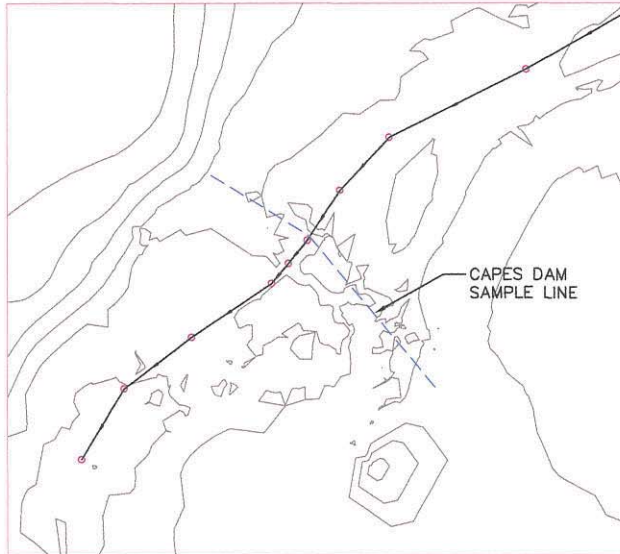
EXISTING CONDITION: SAMPLE LINE CROSS SECTION UPSTREAM OF CAPES DAM

EXISTING CONDITION: SAMPLE LINE CROSS SECTION PARALLEL WITH CENTERLINE OF DAM'S LONG AXIS

EXISTING CONDITION: SAMPLE LINE CROSS SECTION DOWNSTREAM OF CAPES DAM

LOCATION OF SAMPLE LINE USED TO DEVELOP EXISTING CONDITIONS AT CAPES DAM

None of these drawings have a horizontal scale so measurements of the areas (2D) and volumes (3D) are not possible. Is this typical of the quality of work done by engineers employed or contracted to USFWS? The entire point of engineers' drawings are to have a certified measurements of physical structures. But when an organization assigns work to an engineer located over 1,000 miles away from the subject of his drawings, accuracy and useful data can be lacking.
